COMMON AREA REVIEW

A Firewise Review of Wild River Homeowner's Association Common Areas

Jim Stone, Retired Silviculturist, February 17, 2022

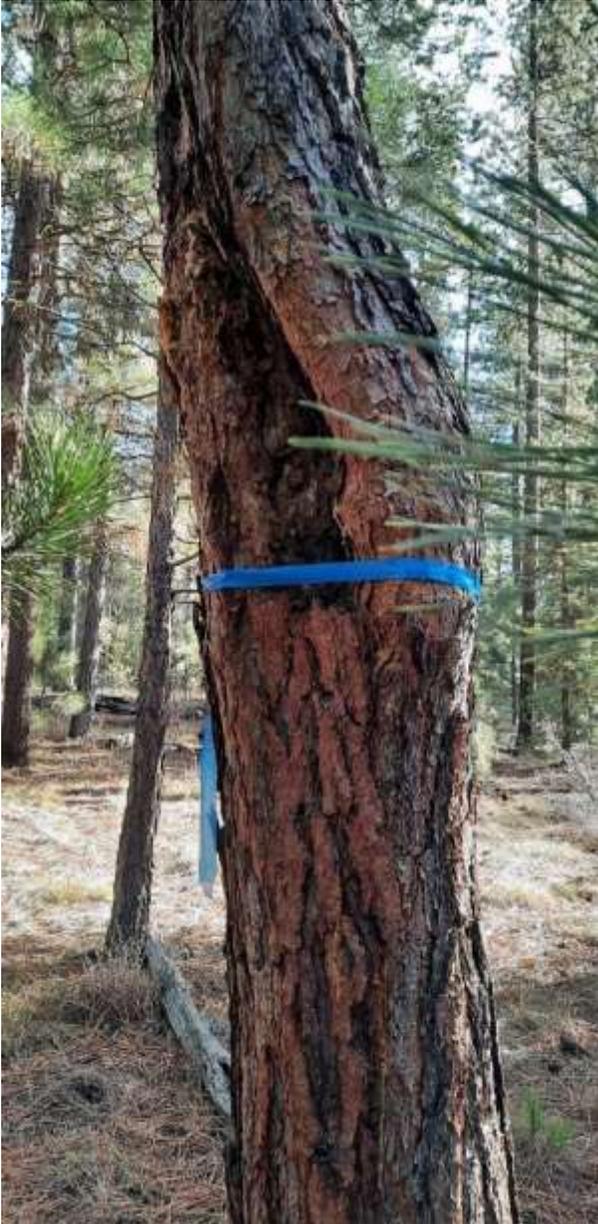
An example of PP with western gall rust causing a weak spot in the stem.

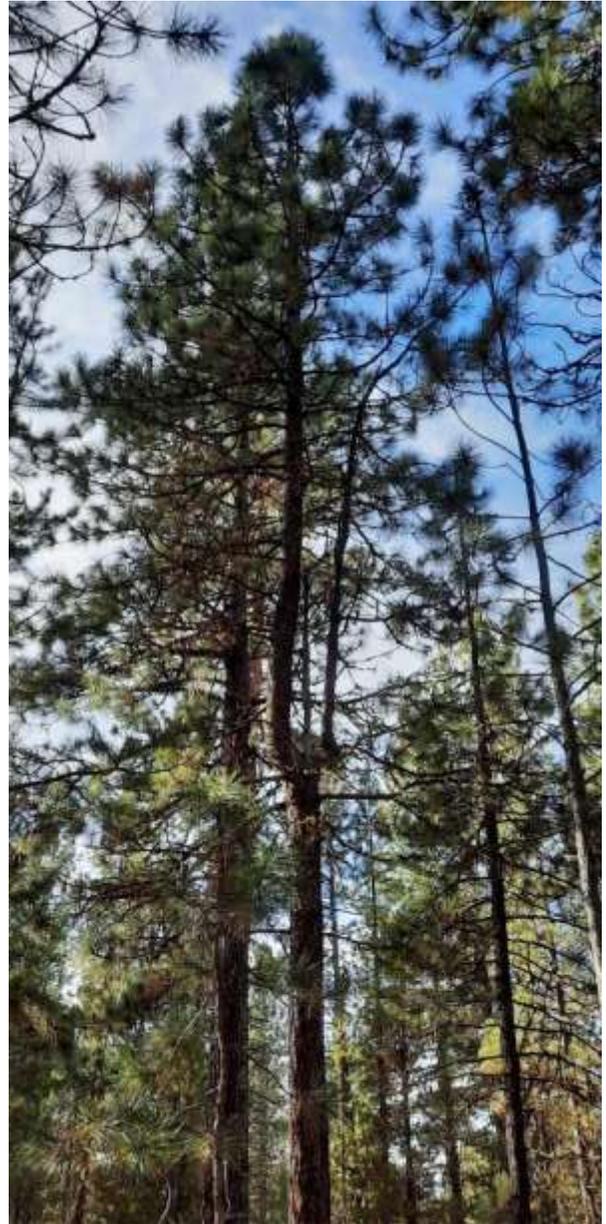
Trees with forks and/or multiple tops.

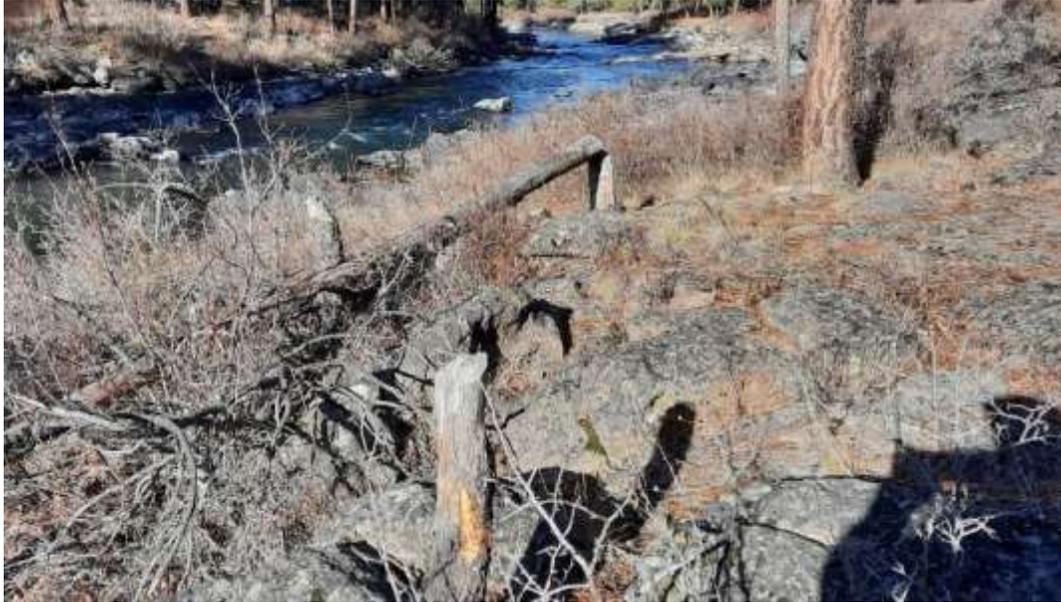
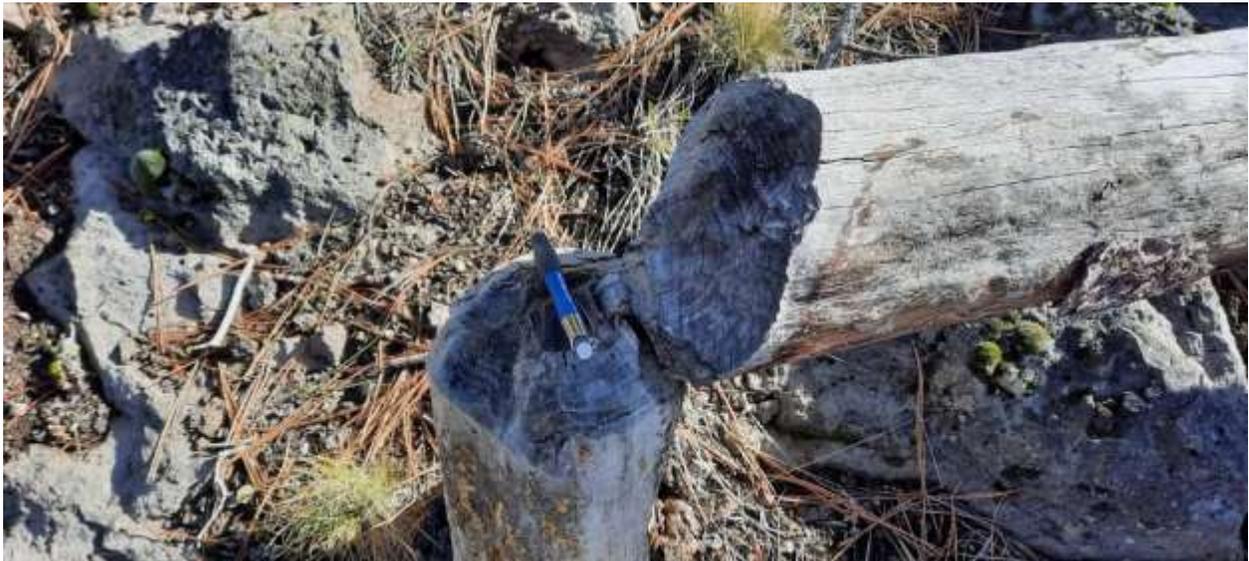
Beaver activity on the LP in Common Area OS.

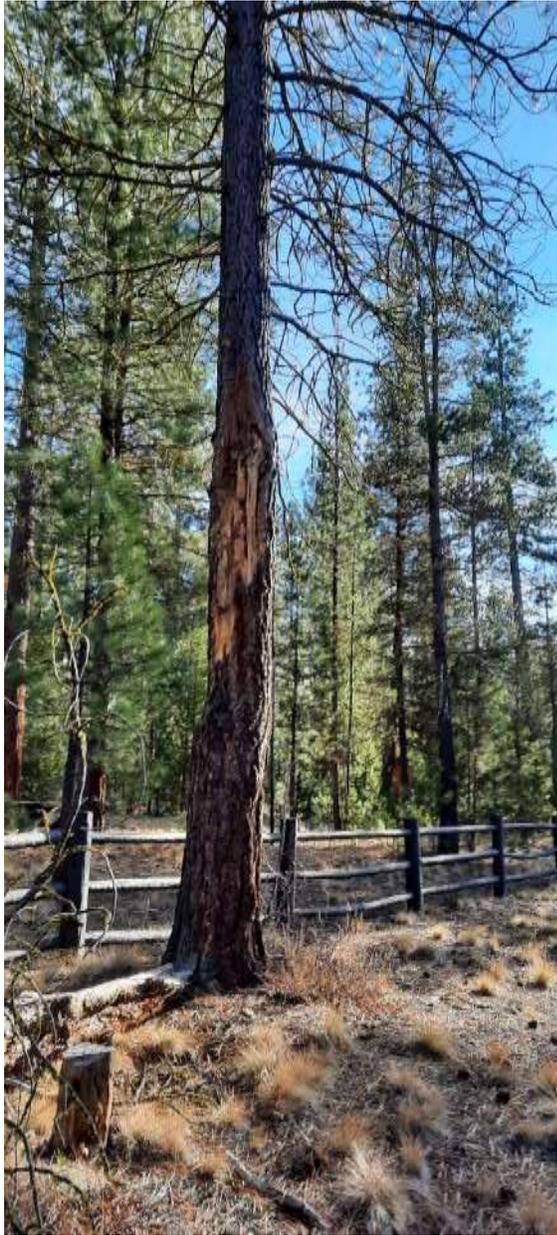
The residual scar from the forked top breaking away leaves opportunity for rot to enter the already weakened area of stem.

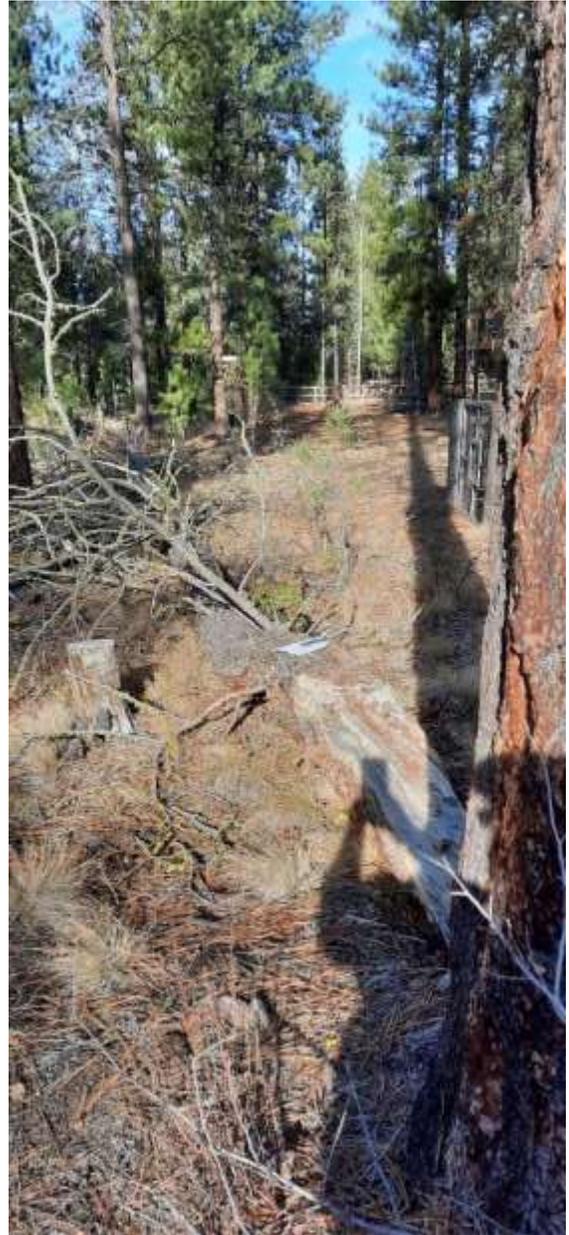
An example of PP forked top that broke away from the main stem. The notebook and pencil are for scale.
