COMMON AREA REVIEW

A Firewise Review of Wild River Homeowner's Association Common Areas

Jim Stone, Retired Silviculturist, February 17, 2022

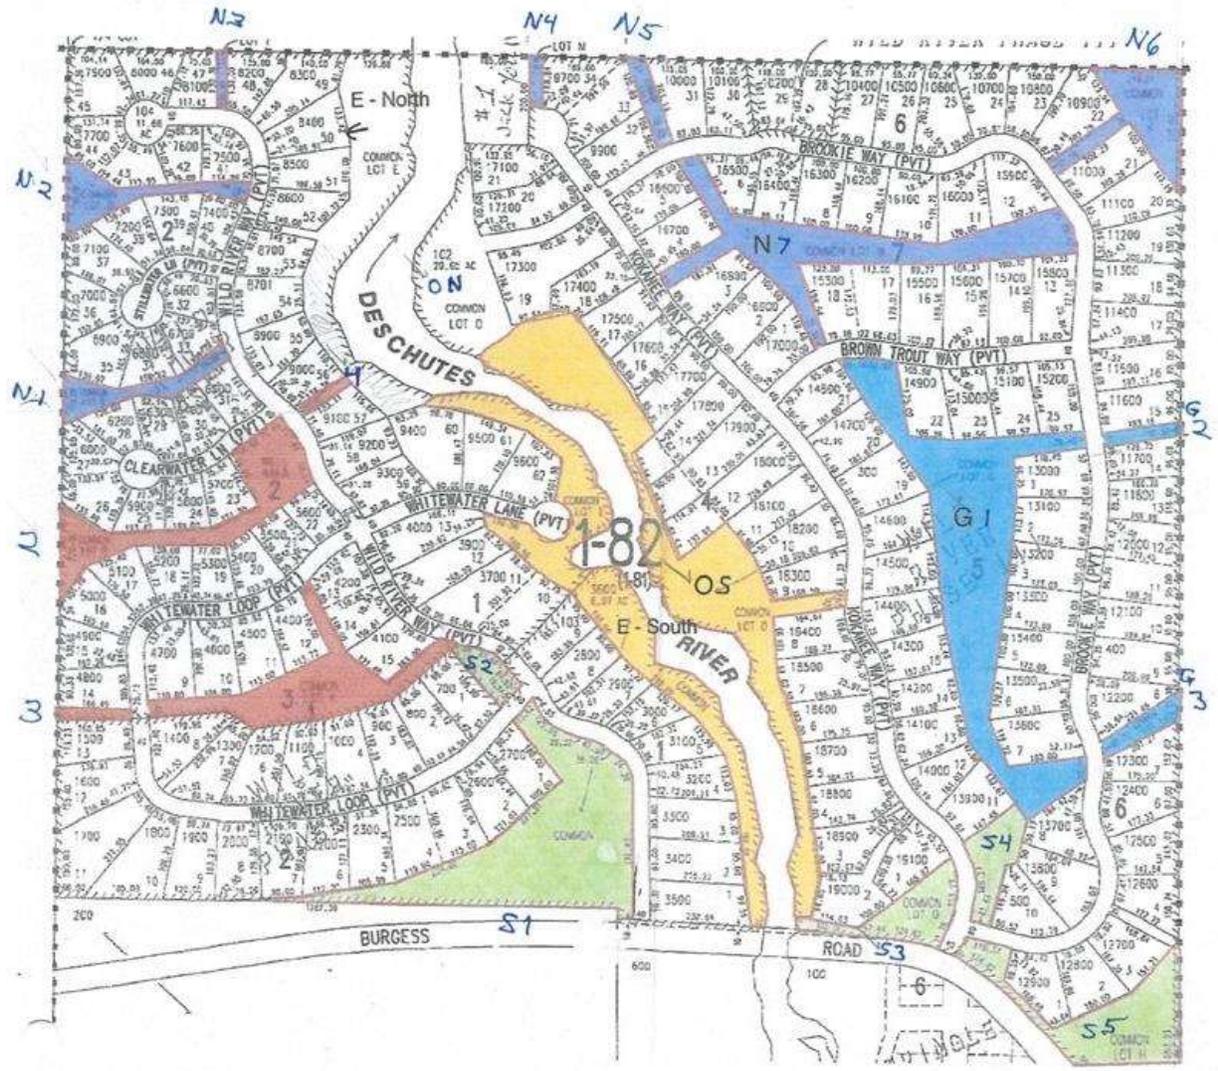
Figure 2 – Map used to identify Common Areas

I received a map of the common areas from Ken Kennedy. The resolution of the map was quite small, and I wasn't sure what the designation was for each of the common areas. Figure 2 shows the designations I used to label each of the common areas and my notes are tied to those designations.
